Appendix F

Photograph Log

Outfall Site Visits

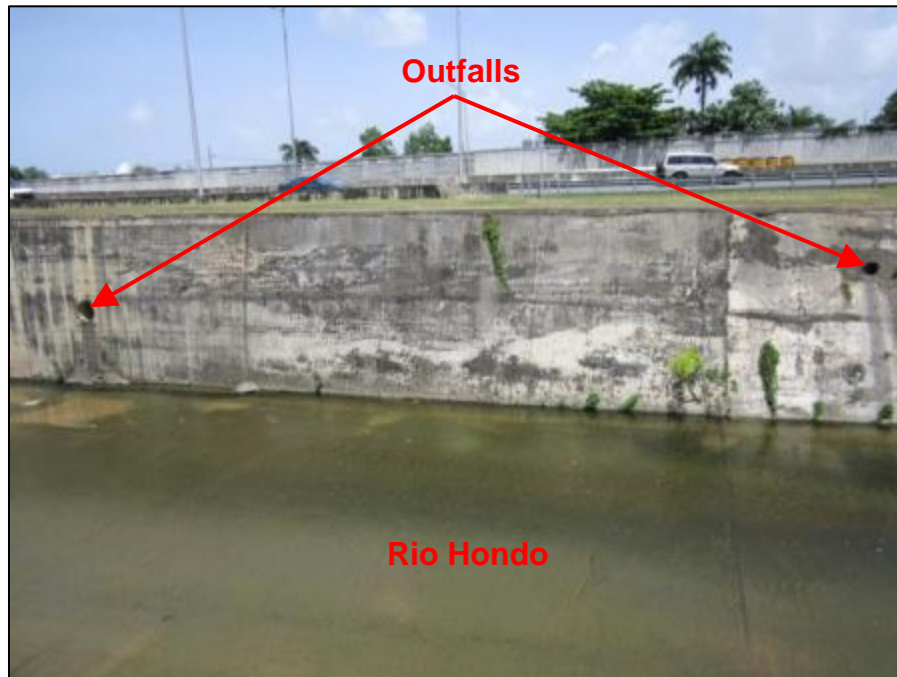
Photograph 1. View of outfalls along east side of the Rio Hondo.

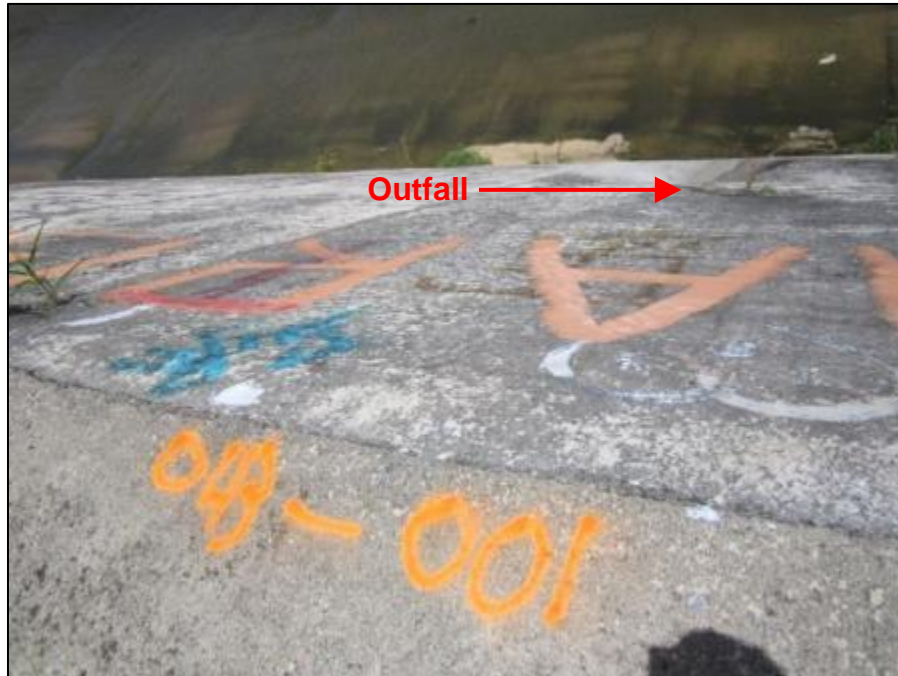
Photograph 3. Close-up view of outfall number spray painted on concrete structure for outfall shown in previous photograph.

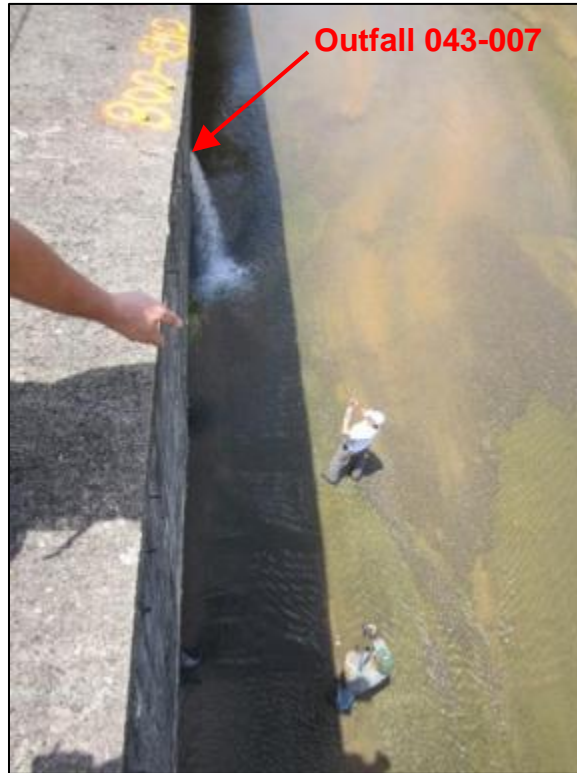
Photograph 5. Additional view of outfall 043-007. Note flow from outfall.

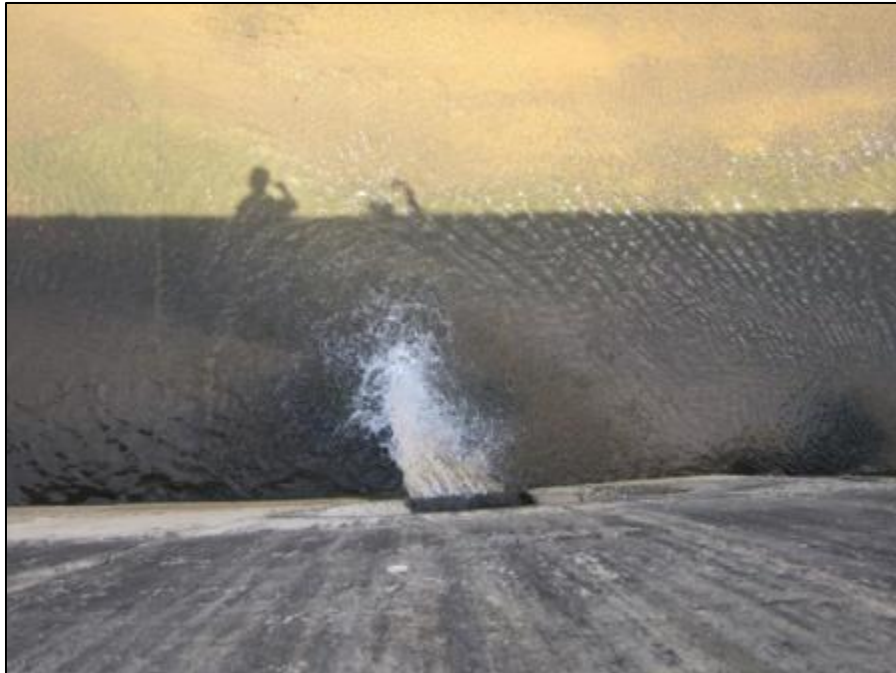
Photograph 6. Close-up view displaying flow from outfall 043-007.

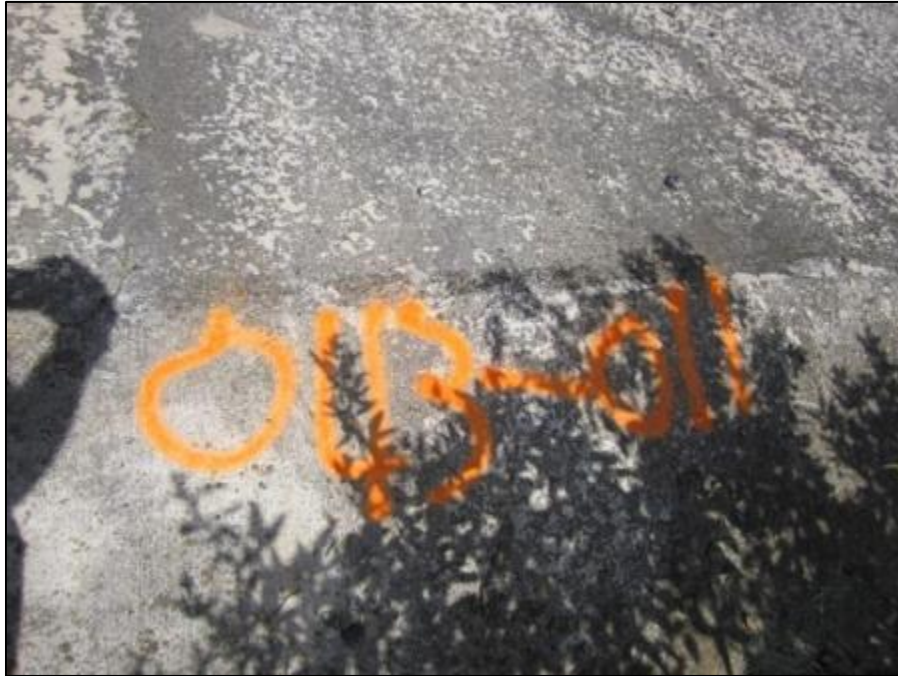
Photograph 7. View of spray painted label for outfall 043-011.

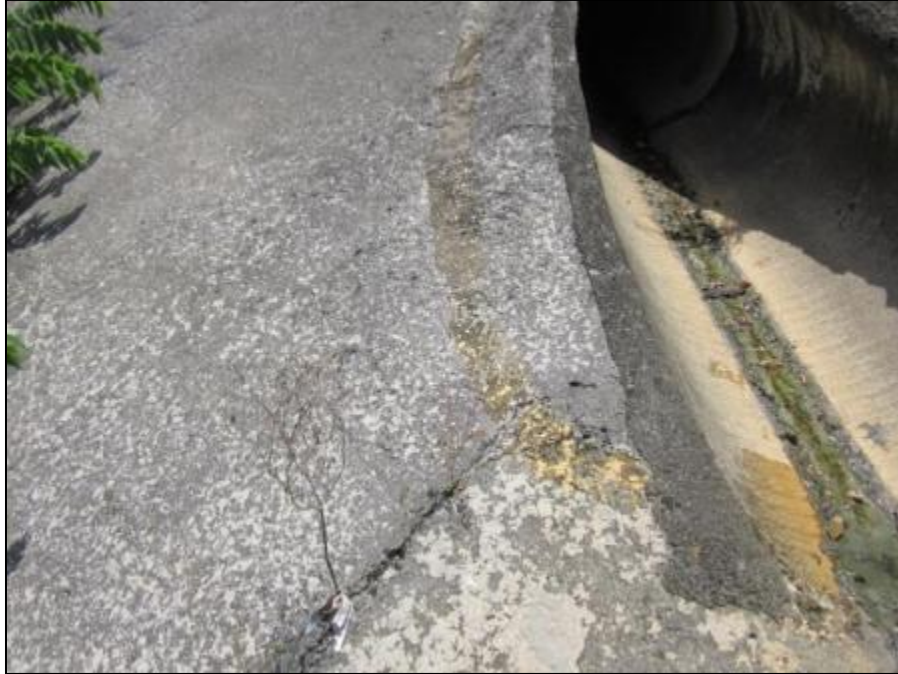
Photograph 9. Additional view of outfall 043-011. Note wetted flow pathway from outfall and algal growth within flow pathway.

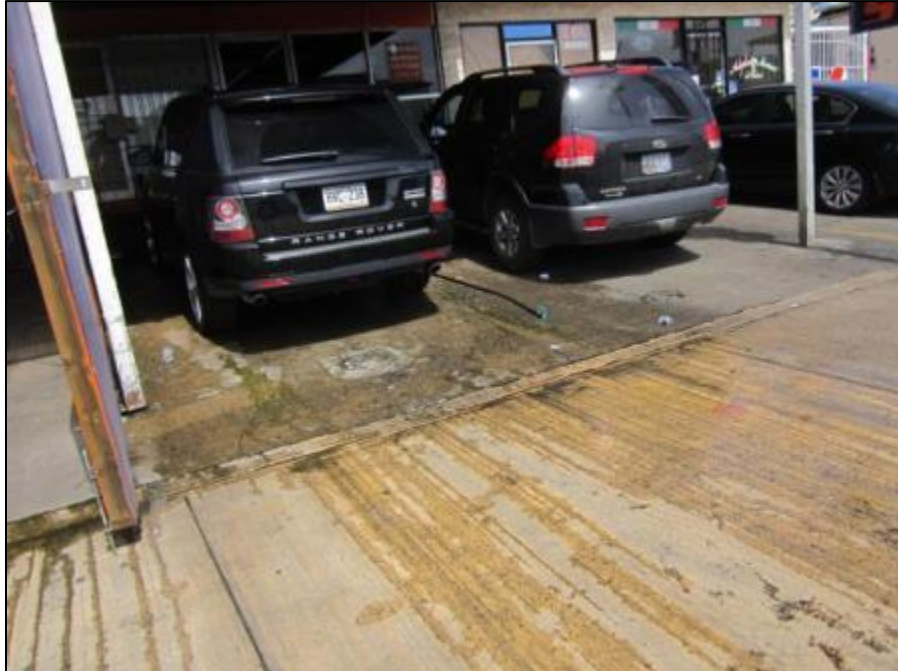
Photograph 12. View of car washing facility and source of wash water shown in previous photograph.

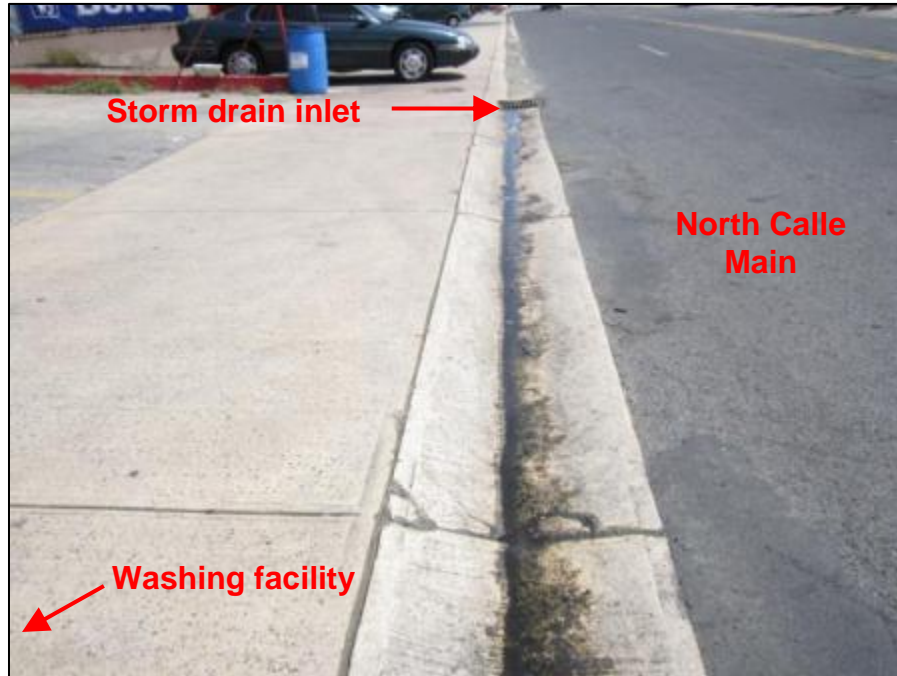
Photograph 13. View of storm drain inlet downgradient of car washing facility shown in previous photographs.

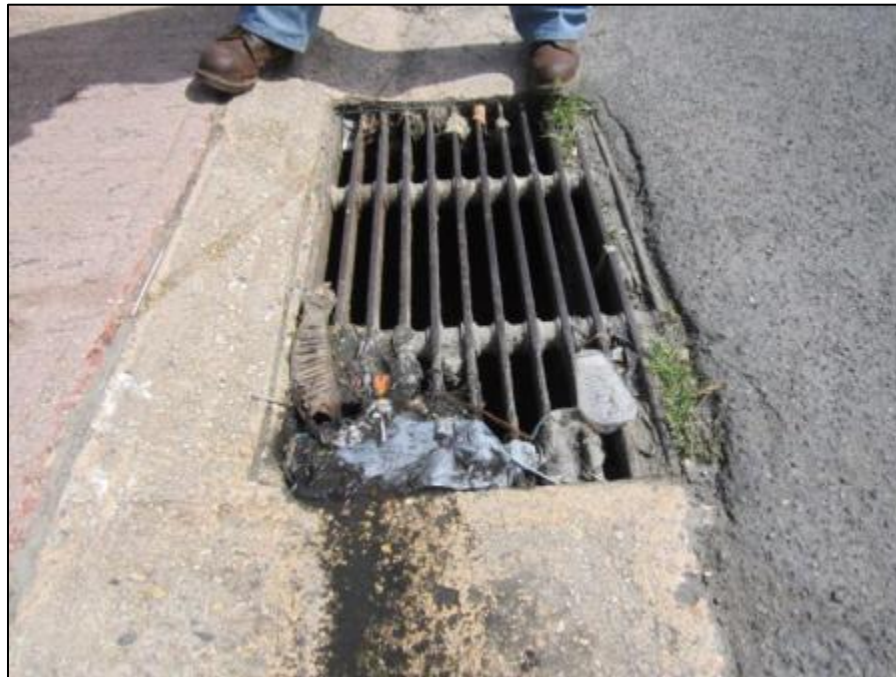
Photograph 14. Closer view of wash water entering storm drain inlet shown in previous photograph.

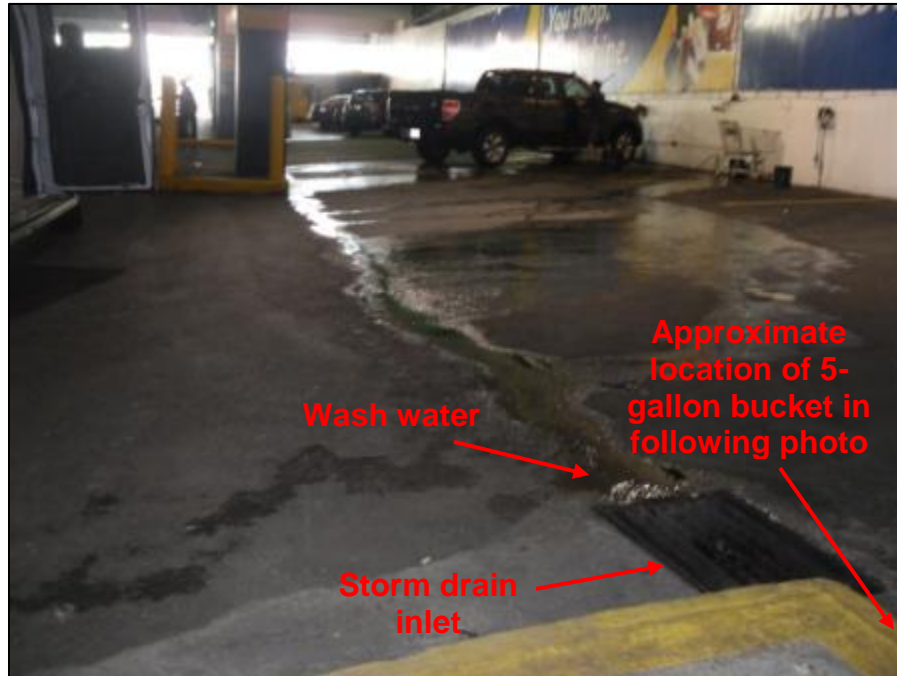
Photograph 15. View of wash water flowing into a storm drain inlet inside the car washing facility in the lower level of the Plaza Del Sol parking garage. Note that the truck in the background was being washed at the time of the inspection.

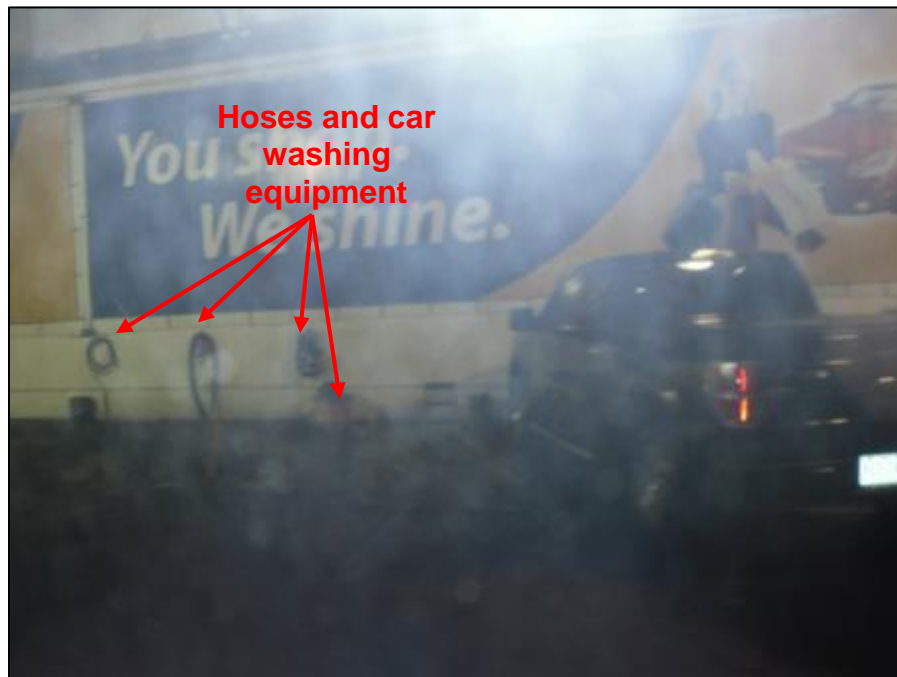
Photograph 16. View of hoses and other car washing equipment located inside the car washing facility.

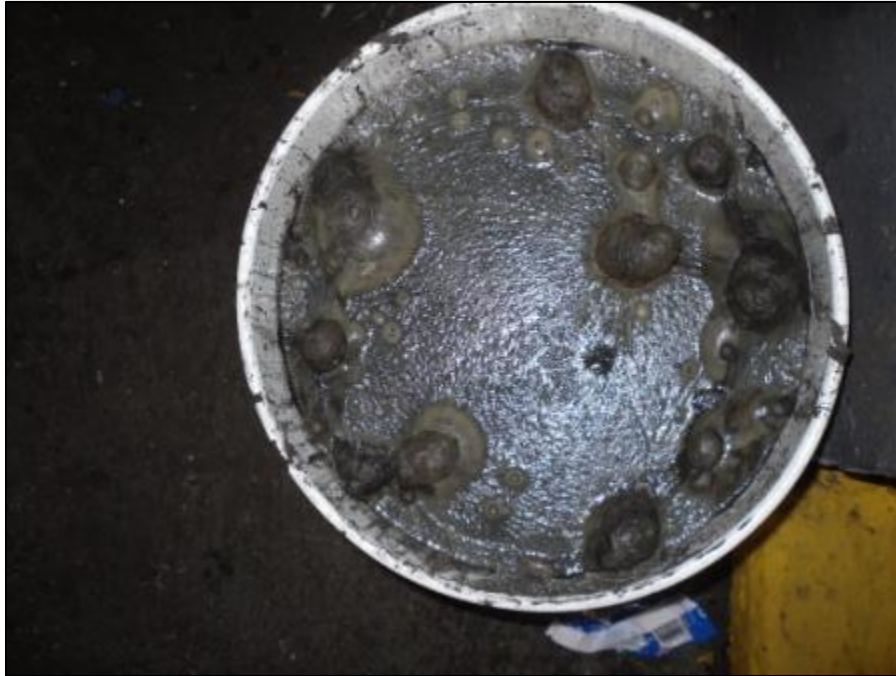
Photograph 17. View of a 5-gallon bucket containing an unknown oily substance. The bucket was located just outside the field of view and immediately upgradient of the storm drain in the previous photograph.

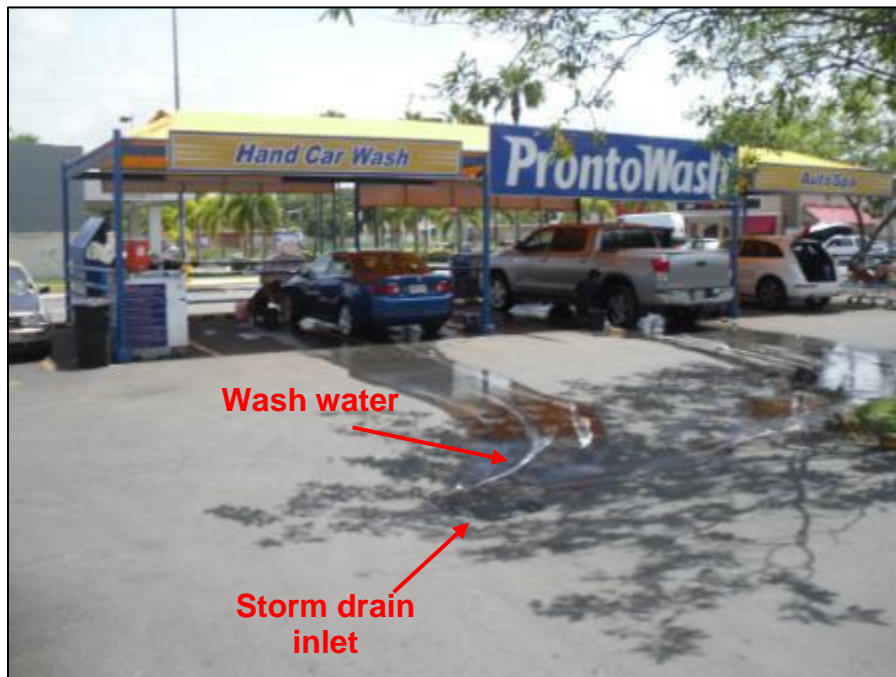
Photograph 18. View of wash water from the outdoor car washing stations flowing into a storm drain inlet.

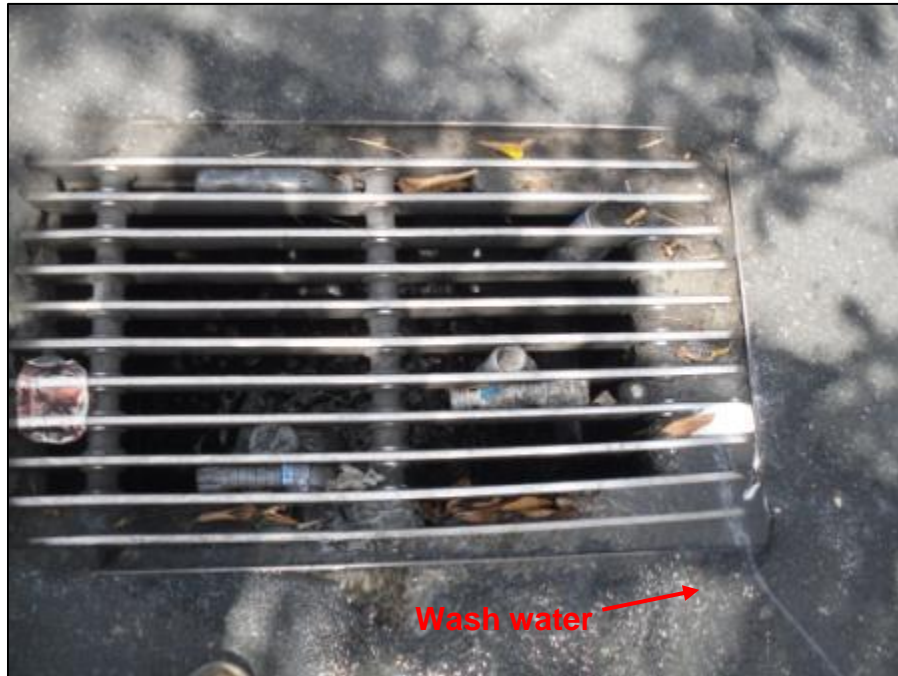
Photograph 19. Close-up view of storm drain inlet shown in Photograph 18.

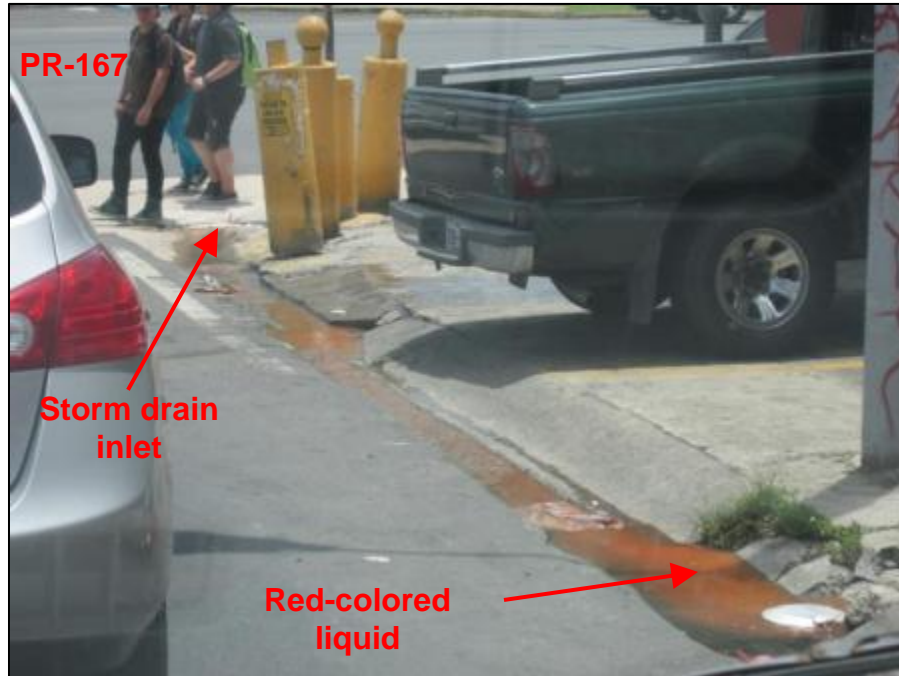
Photograph 21. View of red-colored liquid flowing from pipe in curb to nearby storm drain inlet.

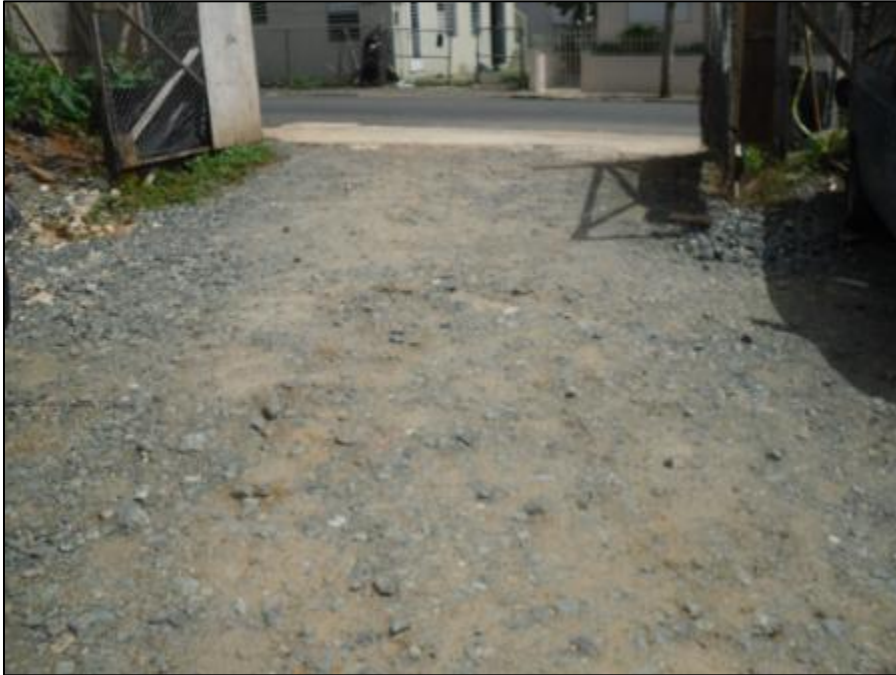
Photograph 23. View of the compacted construction site entrance from Calle Los Millones.

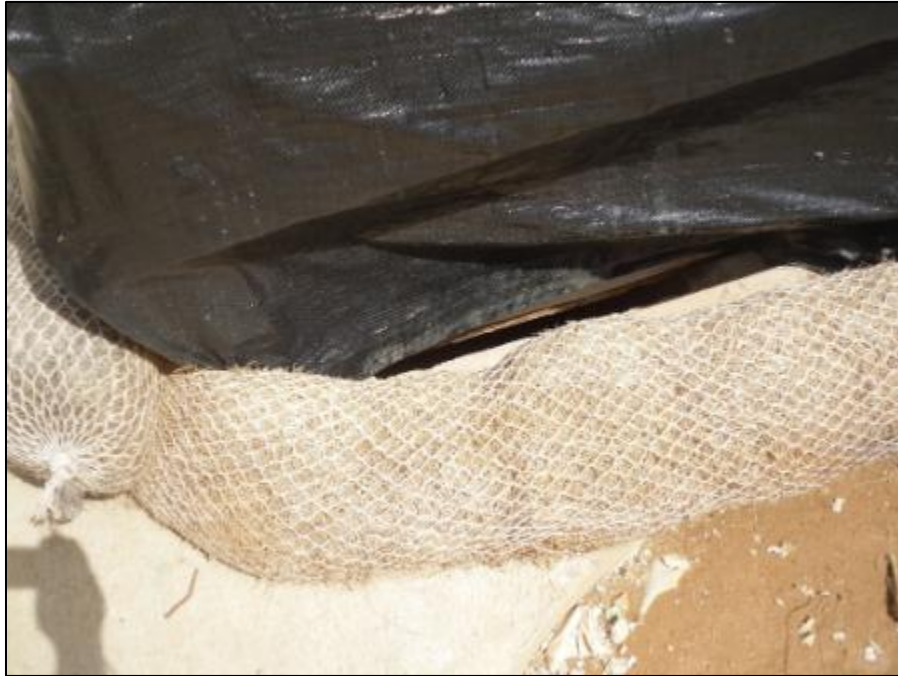
Photograph 31. Close-up view of the silt fence and stormwater wattle shown in Photograph 30. Note that the silt fence was not entrenched into the ground and that there was a gap between the liner and the wattle possibly allowing stormwater runoff from the active construction site into the new inlet structure.

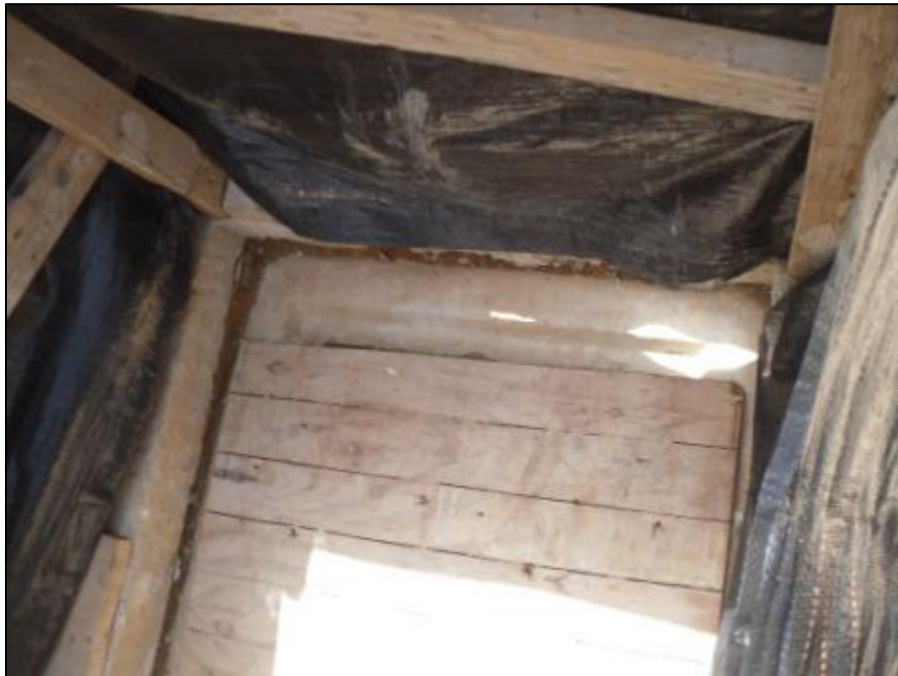
Photograph 32. View of the inside of the silt fence shown in Photograph 31. Note that the inlet structure was also covered by plywood.

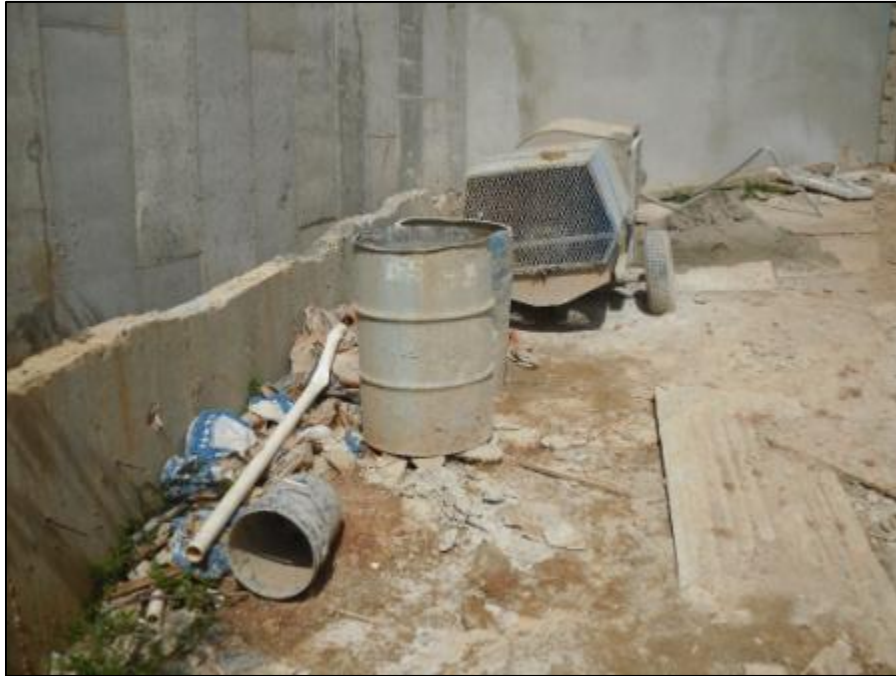
Photograph 35. Close-up view of debris and equipment shown in Photographs 33 and 34.

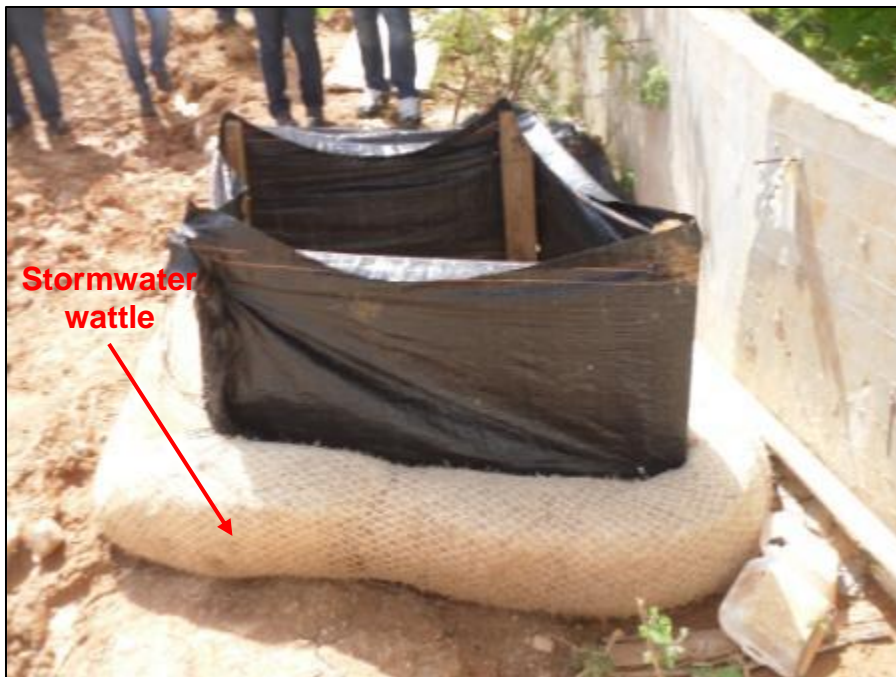
Photograph 36. View of a newly constructed storm drain inlet surrounded by silt fence and stormwater wattles.

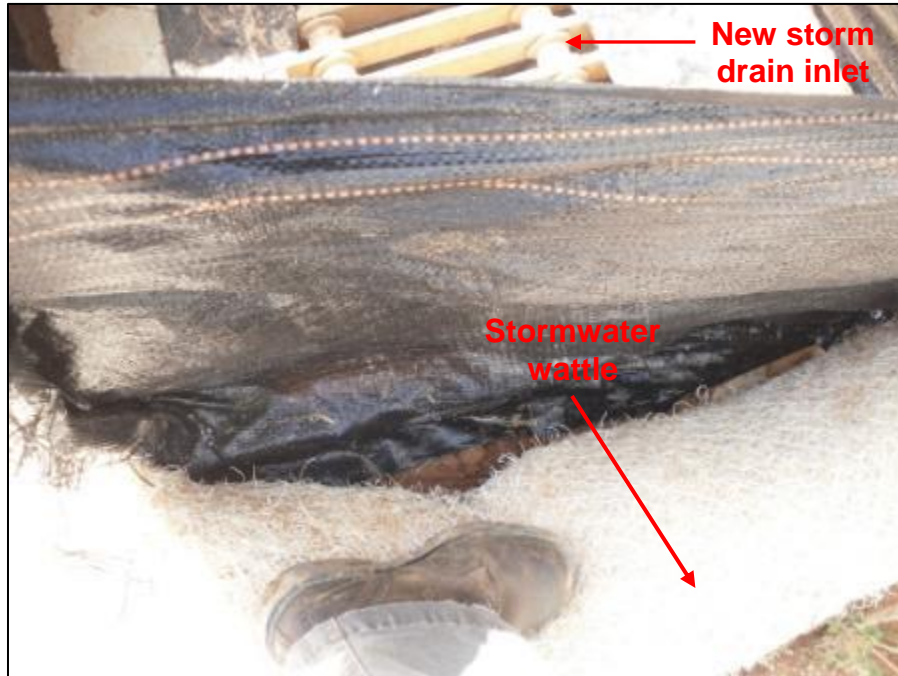
Photograph 37. Close-up view of the silt fence and stormwater wattle show in Photograph 36.

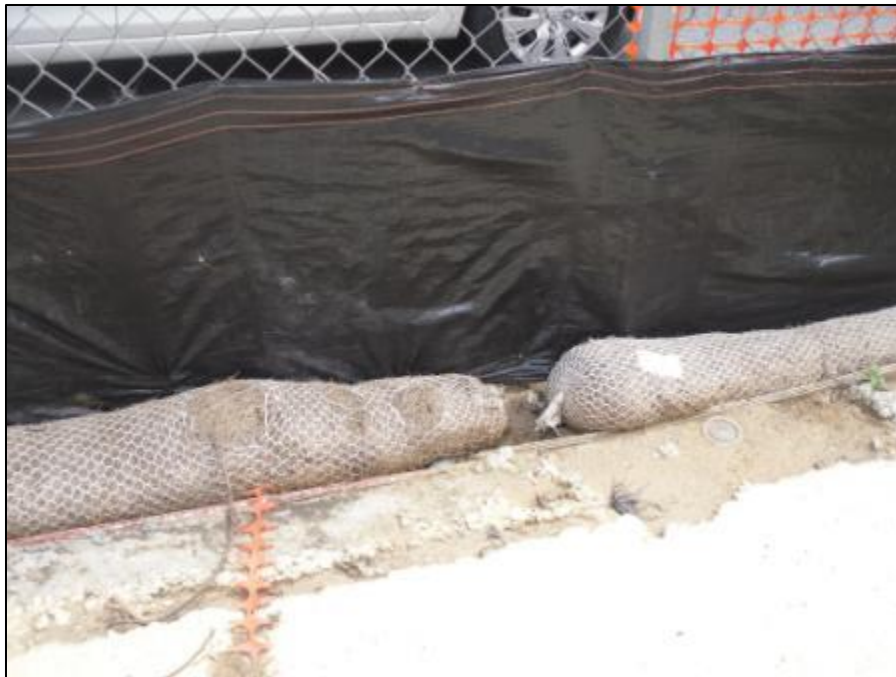
Photograph 40. View from the interior of the construction site of improperly installed silt fence and stormwater wattles along Calle Los Millones.

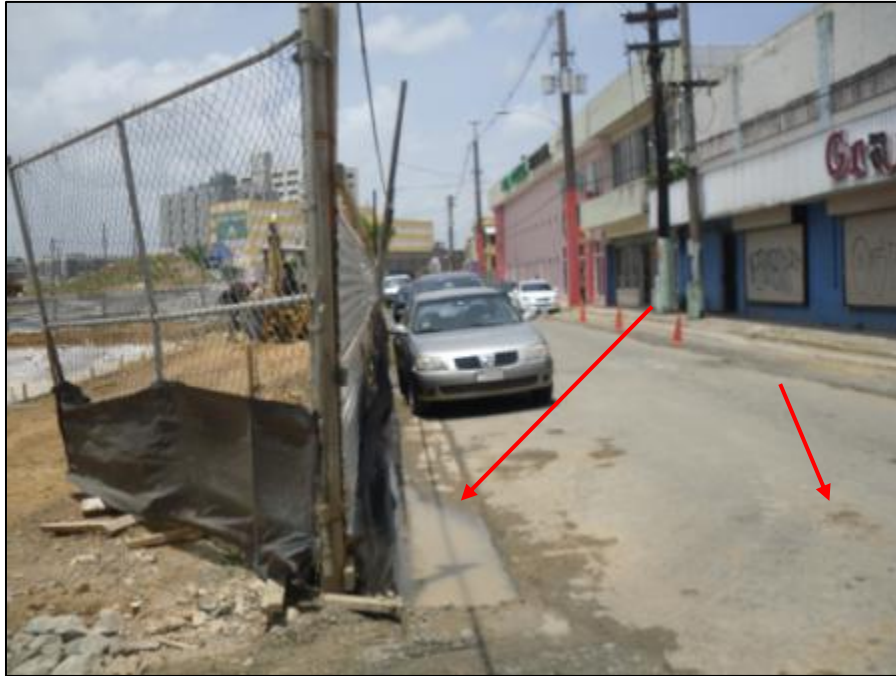
Photograph 46. View of the construction entrance from Dr. Veve Street looking west. Note evidence of tire wash runoff which was tracked onto Dr. Veve Street.

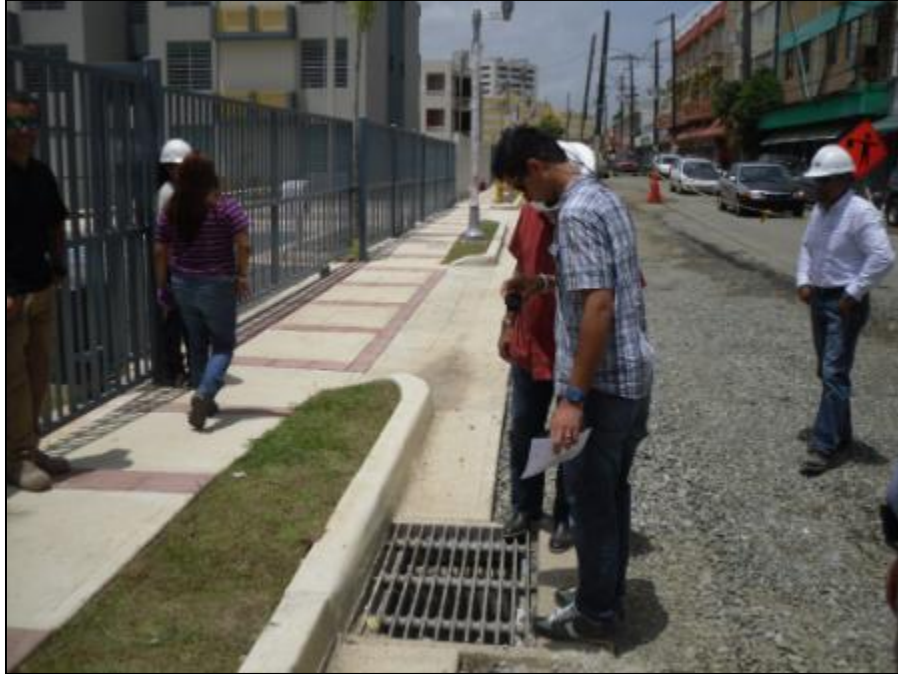
Photograph 50. View of a storm drain inlet along Dr. Veve Street without BMPs for inlet protection.

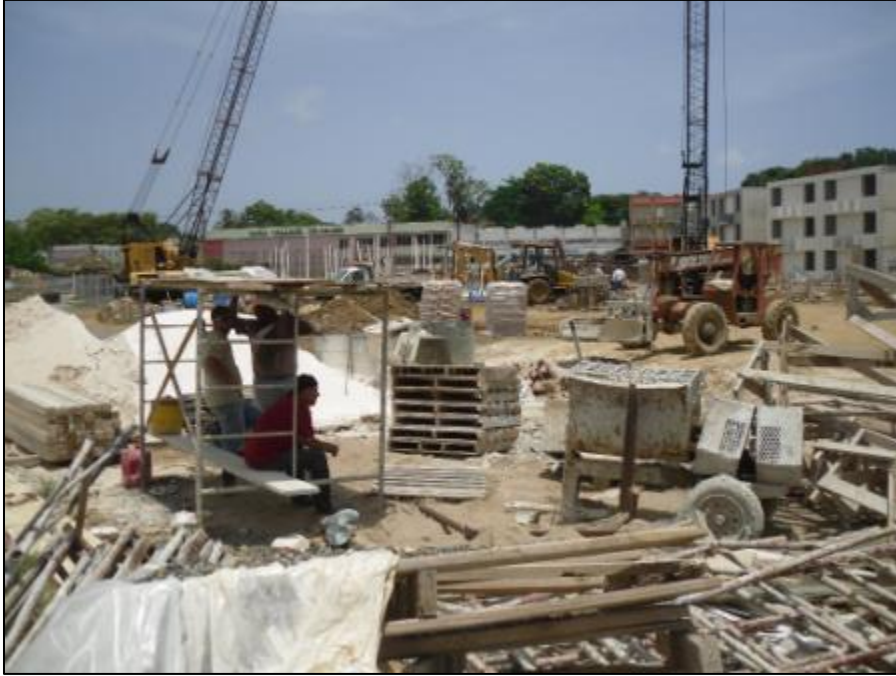
Photograph 54. Scattered debris, equipment and uncontrolled material stockpiles in the middle of the construction site.

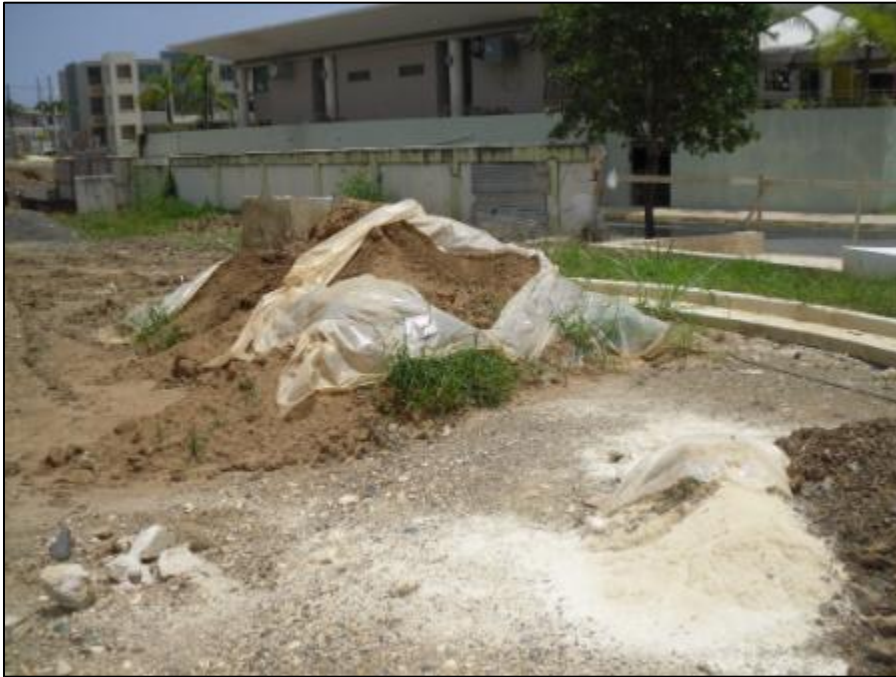
Photograph 55. View of a soil stockpile and concrete residue on the east side of the construction site.

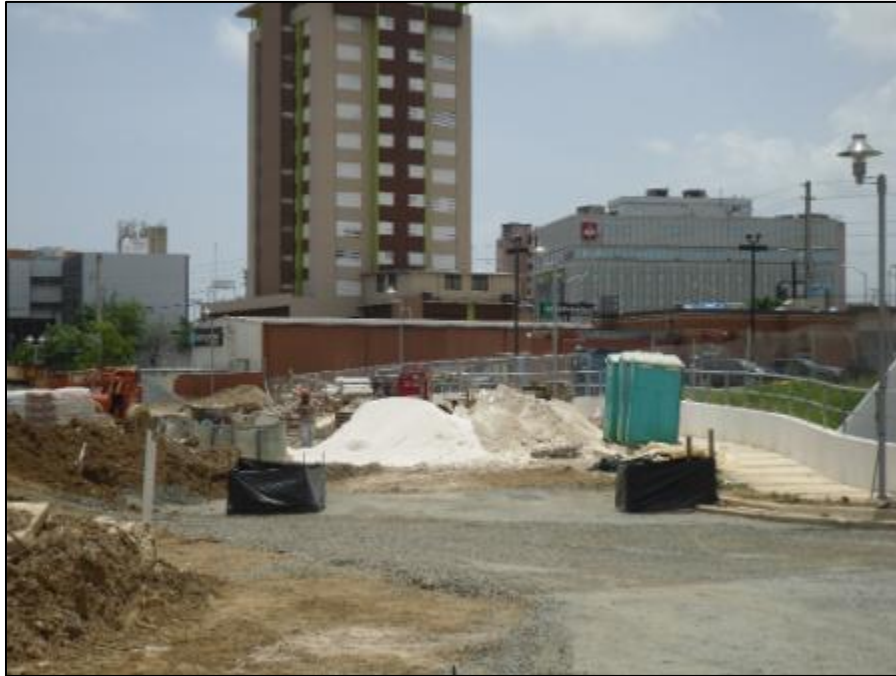
Photograph 56. View of two newly constructed storm drain inlets surrounded by incorrectly installed silt fence. Note the uncontrolled stockpiles and proximity of portable toilets to the storm drain inlets.

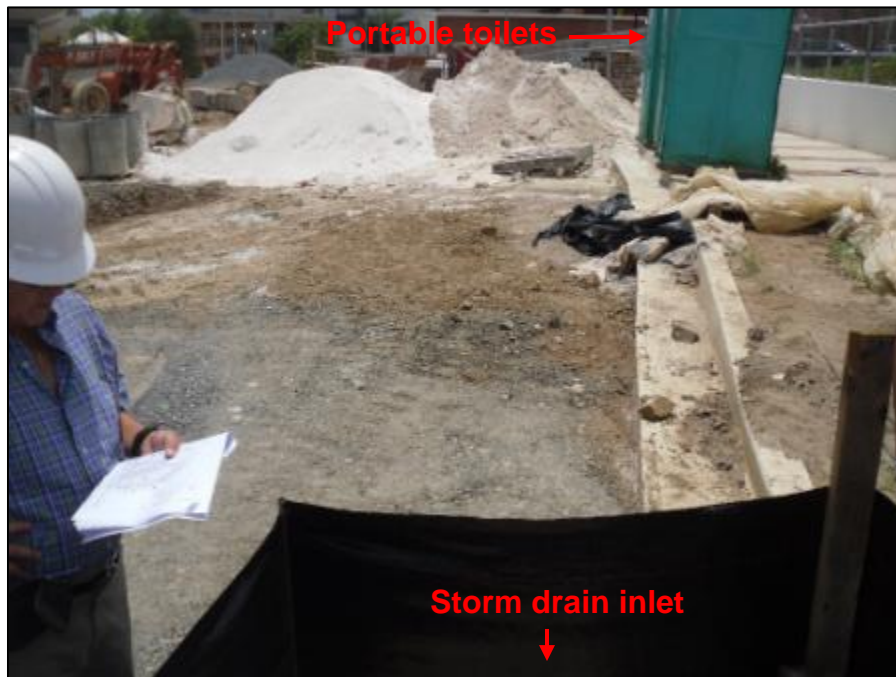
Photograph 57. Additional view of scattered debris and equipment in close proximity to the storm drain inlets shown in Photograph 56. Also note the proximity of the portable toilets to the curb and gutter draining to the inlet.

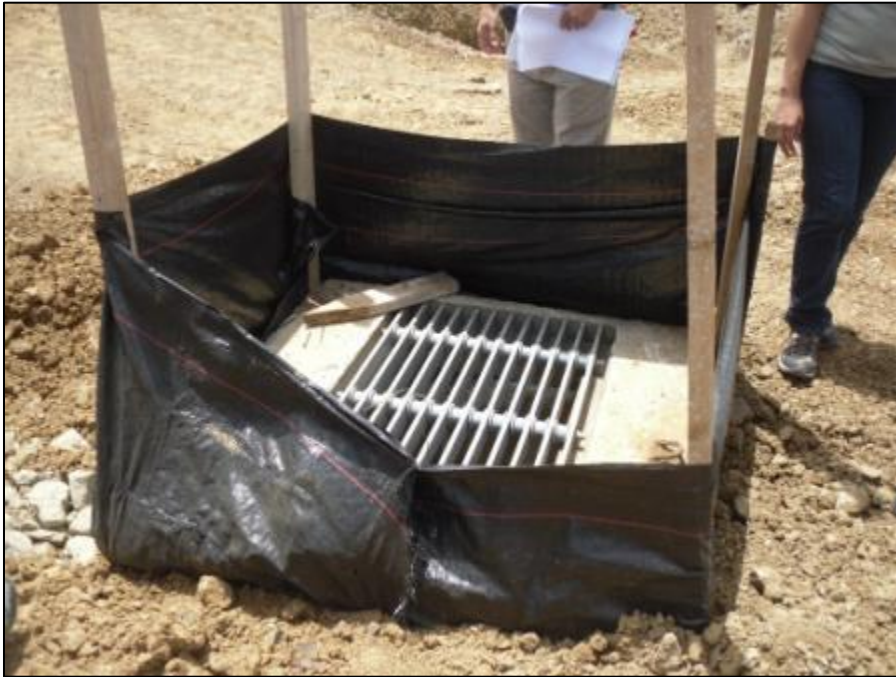
Photograph 61. View of another newly constructed storm drain inlet surrounded by incorrectly installed silt fence (e.g., not entrenched).

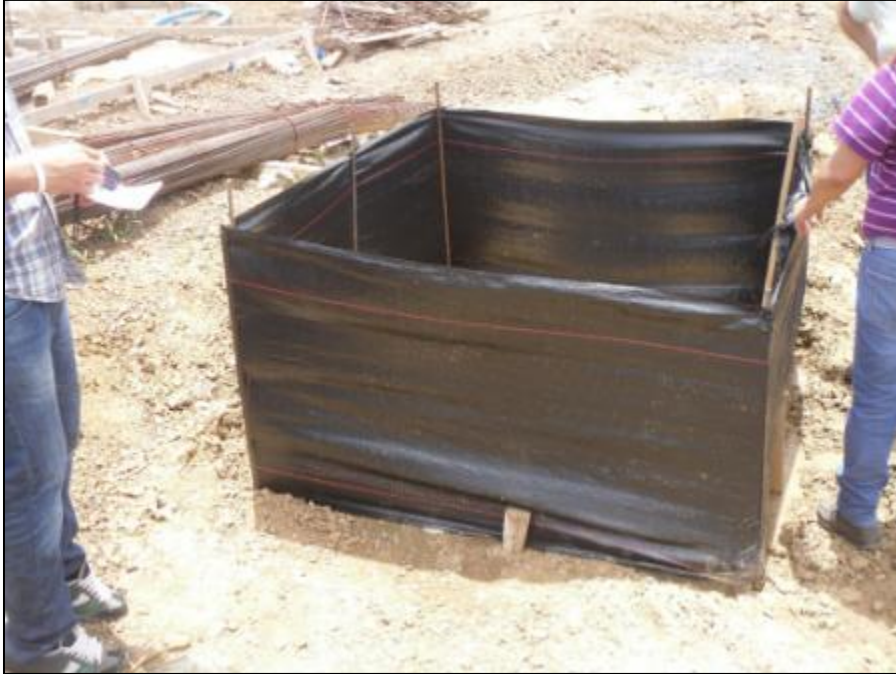
Photograph 62. View of another newly constructed storm drain inlet surrounded by incorrectly installed silt fence (e.g., not entrenched).

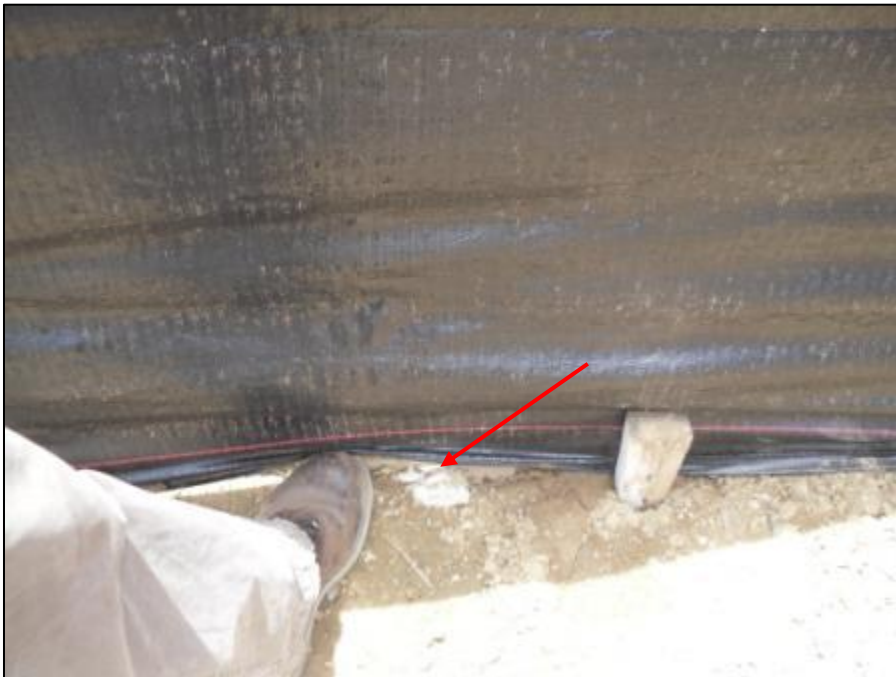
Photograph 63. Close-up view of the silt fence shown in Photograph 62.

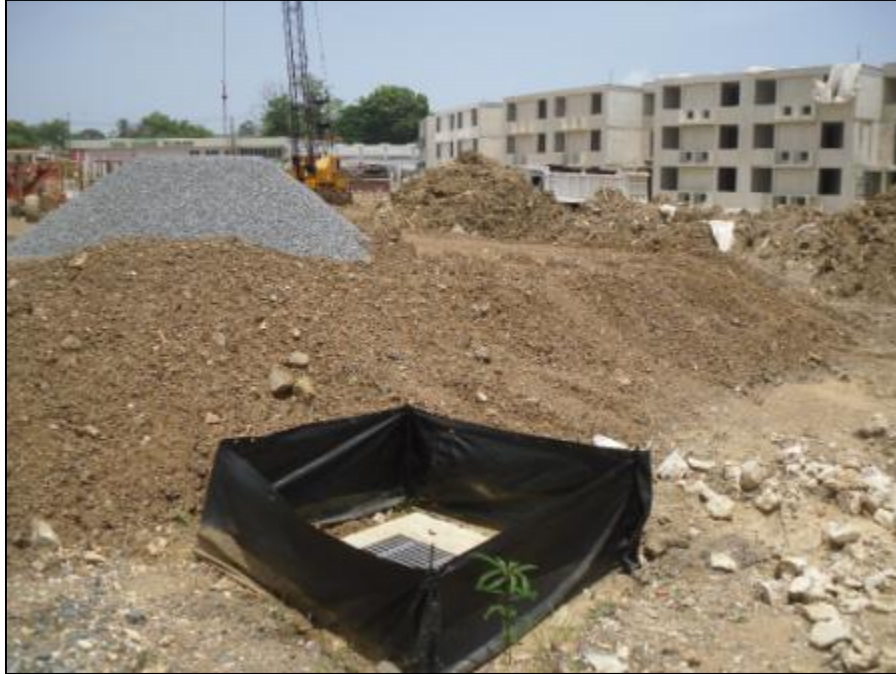
Photograph 64. View of another newly constructed storm drain inlet surrounded by incorrectly installed silt fence (e.g., not entrenched).

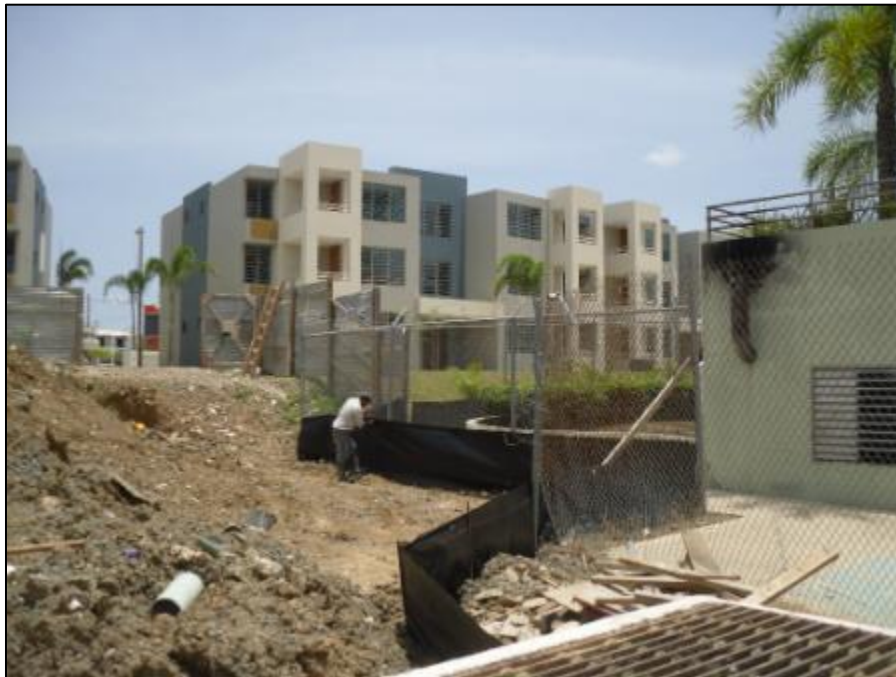
Photograph 65. View of a construction worker installing silt fence around the eastern perimeter of the site. Note that the silt fence was not properly entrenched.

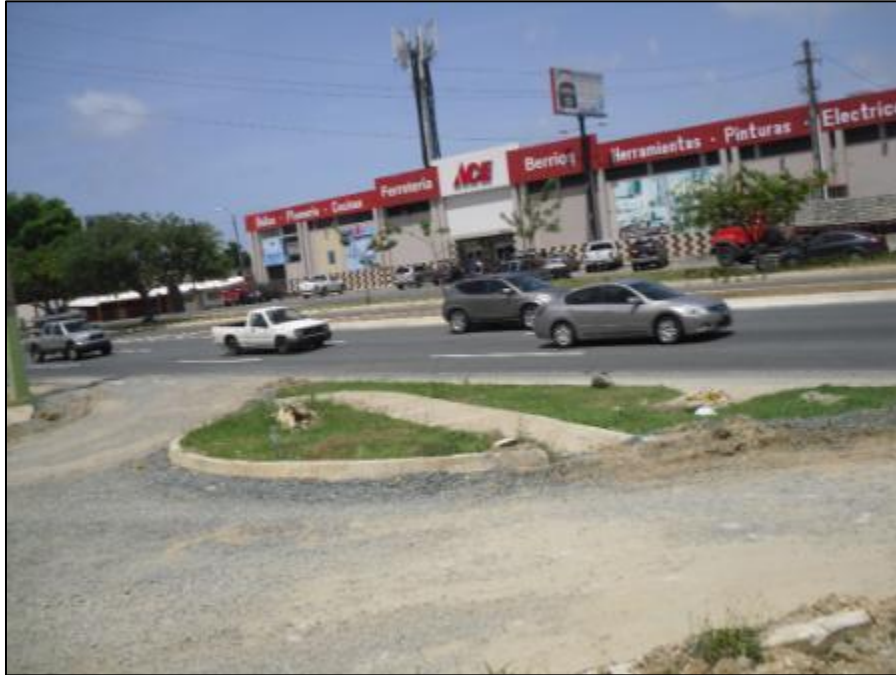
Photograph 66. View of compacted construction site entrance to PR-167 facing east.

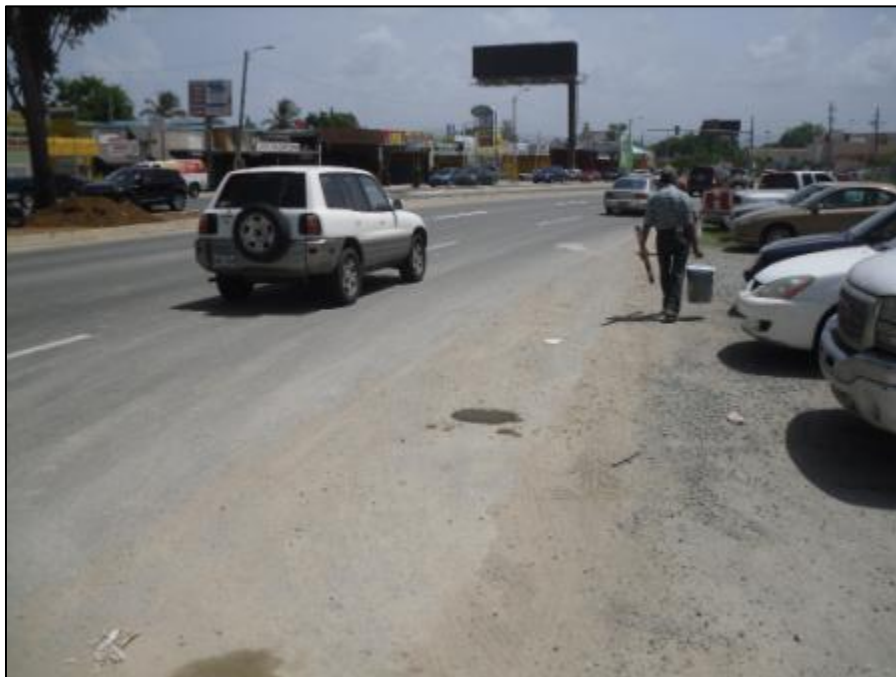
Photograph 67. View immediately outside the construction site entrance on PR-167 facing south. Note that track out from construction equipment and vehicles was observed.

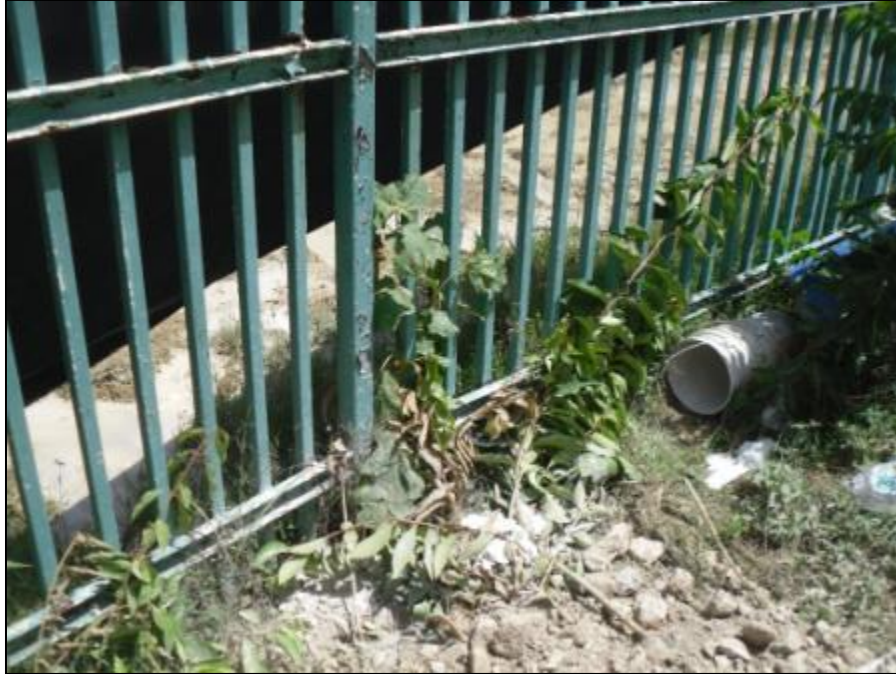
Photograph 70. Evidence of sediment migrating toward the fence line of the site near the construction entrance along PR-167.
